Type of Project	Port - Bulkhead
Purpose of Piling	Repair Failing Bulkhead Wall
Site Location	San Juan, Puerto Rico
Duration of Work	January - February 2012
Owner	FC San Juan Waterfront, LLC
Main Contractor	QB Construction Co.
Piling Contractor	Blue Iron Foundations and Shoring, LLC
Equipment Used	SCZ675WVG Silent Piler

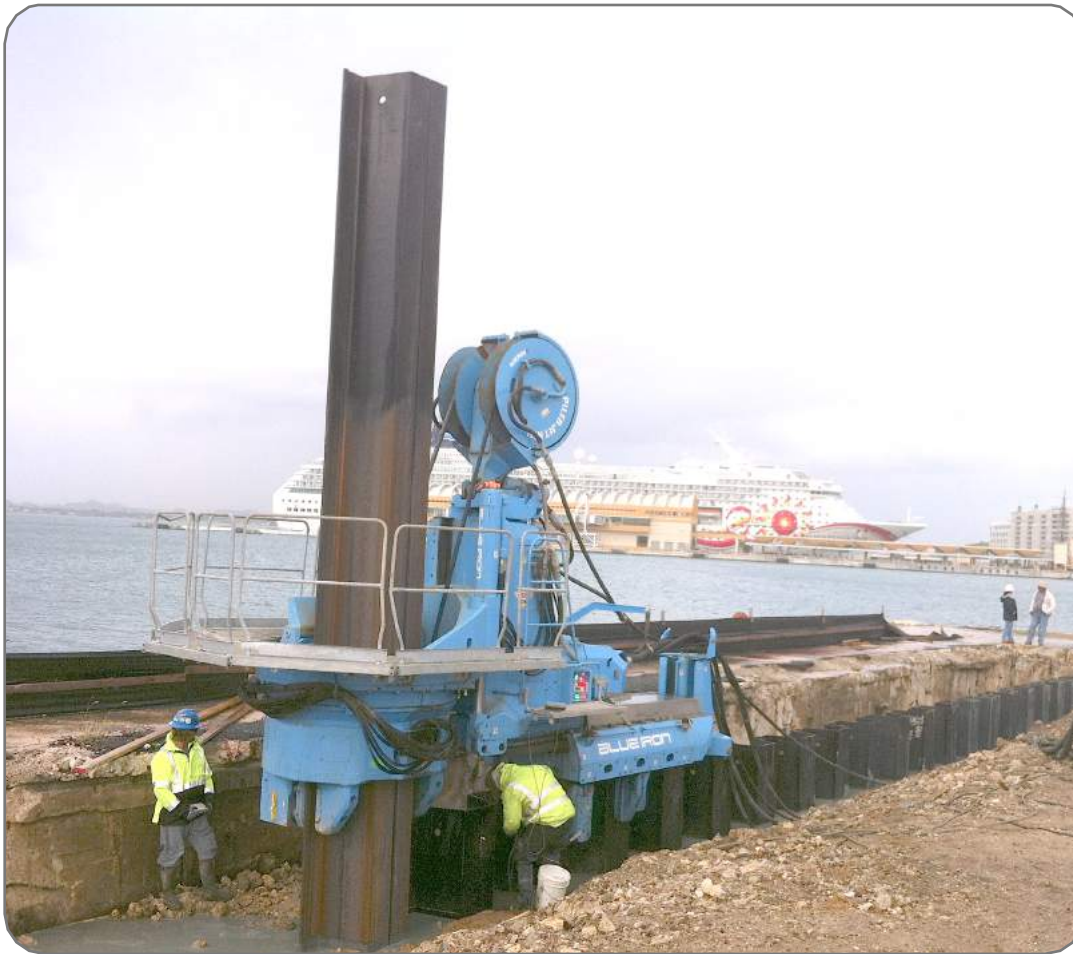
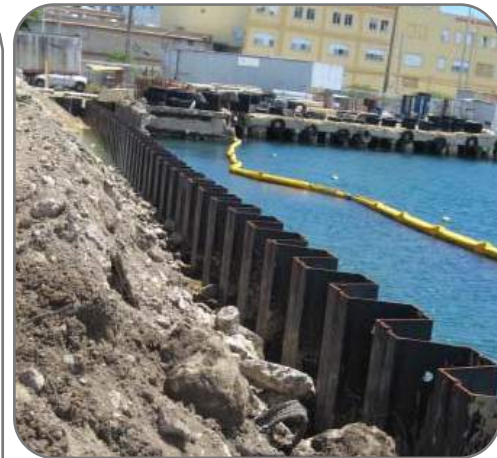
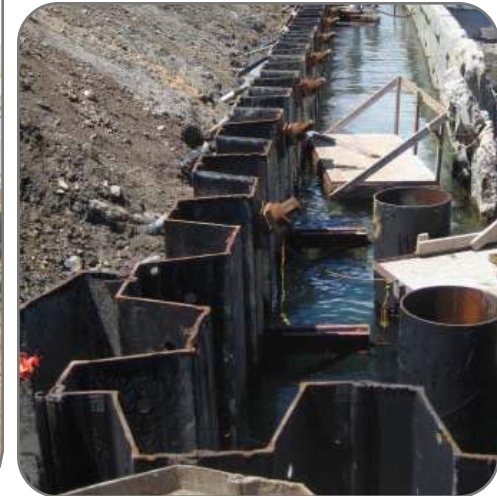
Sheet Pile Material	Arcelor Mittal AZ46 L=55ft
Sheet Pile Supplier	Skyline Steel - Birmingham, AL Office
Description	Piers 7&8 are part of an urban renewal program to turn the existing piers into a park and themed area for incoming cruise ship passengers. The existing bulkhead wall along Pier 8 had already failed, and Pier 7 was in serious disrepair. The Owner and Designers had concerns using a Vibratory Hammer due to the poor conditions and concern of causing additional damage. The clayey soils posed significant problems during installation along Pier 6. All the sheeting were driven to grade without any issues .
